Docket No. 217 – Development and Management Plan Inspection

Northeast Utilities Service Company Certificate of Environmental Compatibility and Public Need for the construction of a 345-kV electric transmission line and reconstruction of an existing 115-kV electric transmission line between Connecticut Light and Power Company's Plumtree Substation in Bethel, through the towns of Redding, Weston, and Wilton, and to the Norwalk Substation in Norwalk, Connecticut.

Date: February 22, 2006

Location: 345kV Underground Route

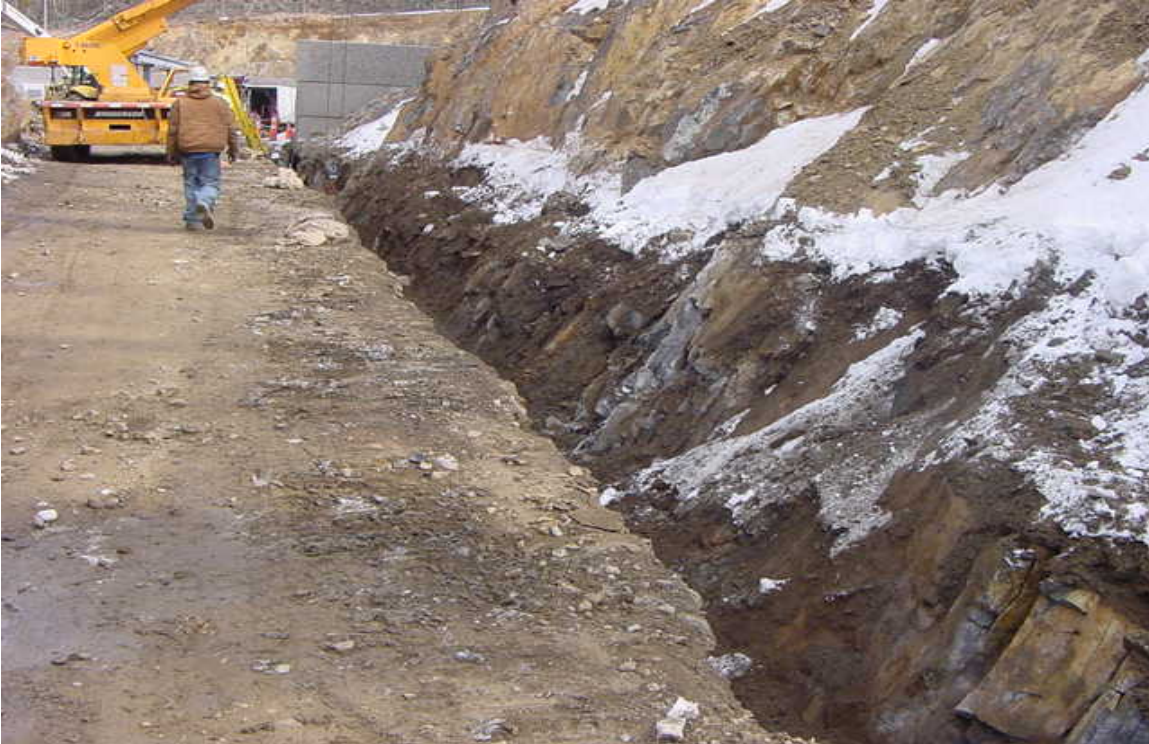
345kV (Archers Lane): View of the trenching for the 345kV work along the access drive into the Archers Lane station. The site remains well contained at this time. Significant dewatering has not been necessary. 2/22/06

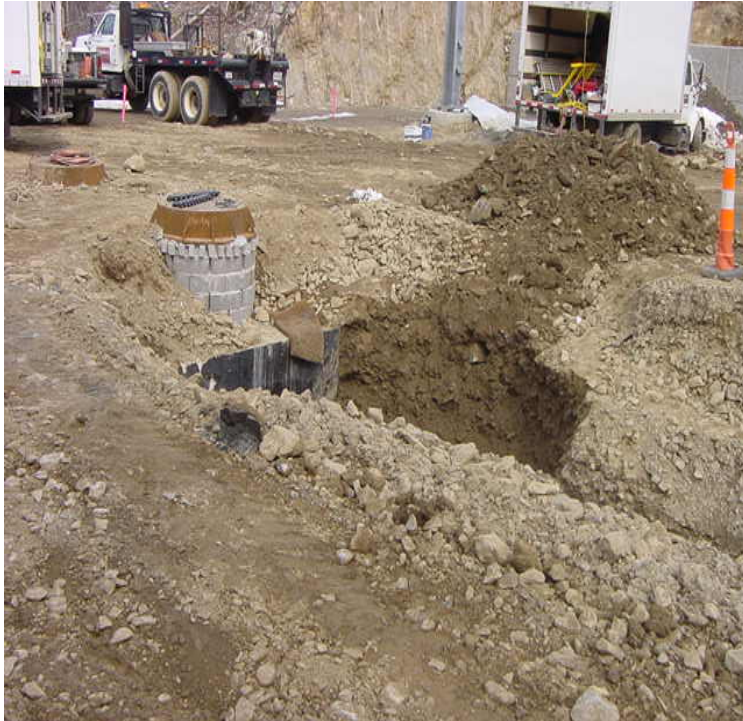
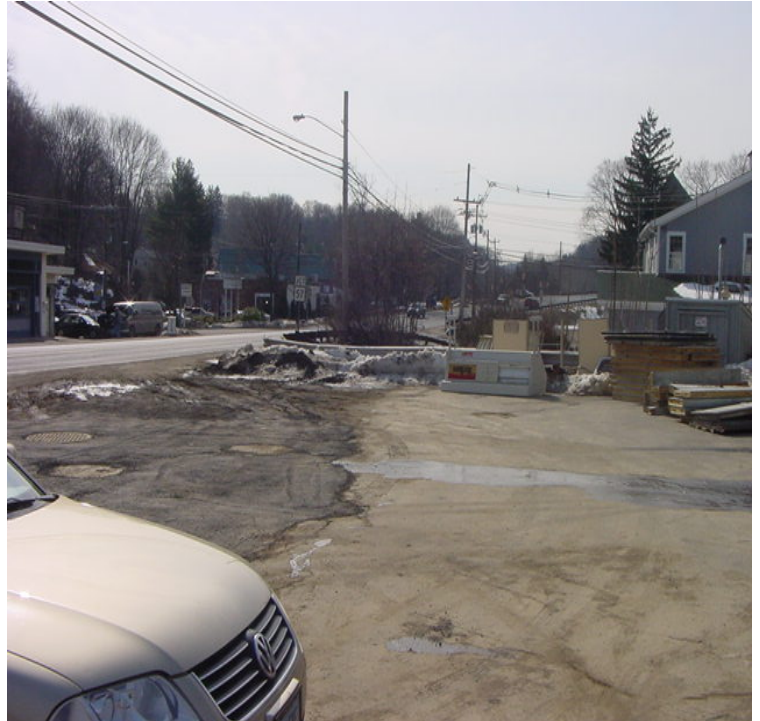
(Archers Lane and Georgetown Deli): Photo on the left shows the trenching continuing up to the vault in the Archers Lane station pad. Photo on the right shows the parking lot at Georgetown Deli. Some leftover materials remain behind. 2/22/06

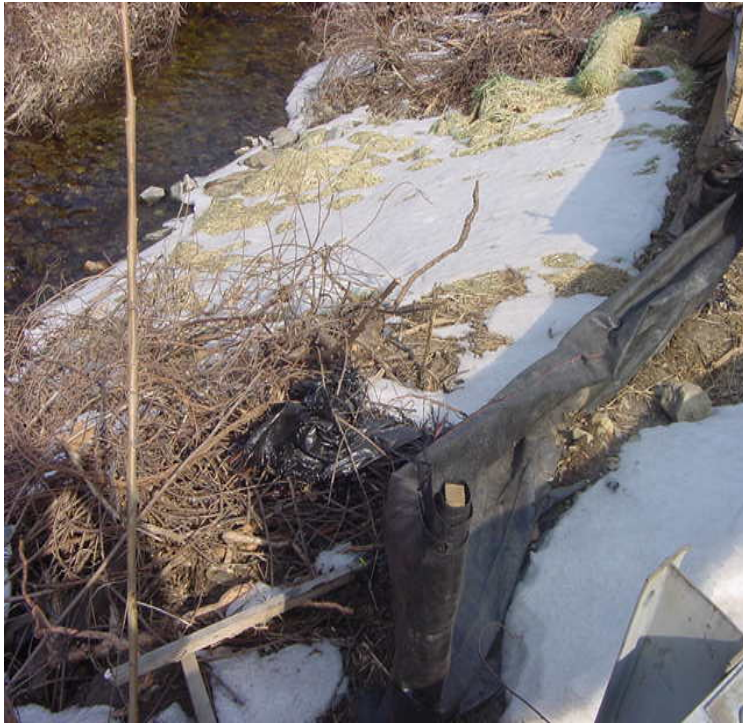
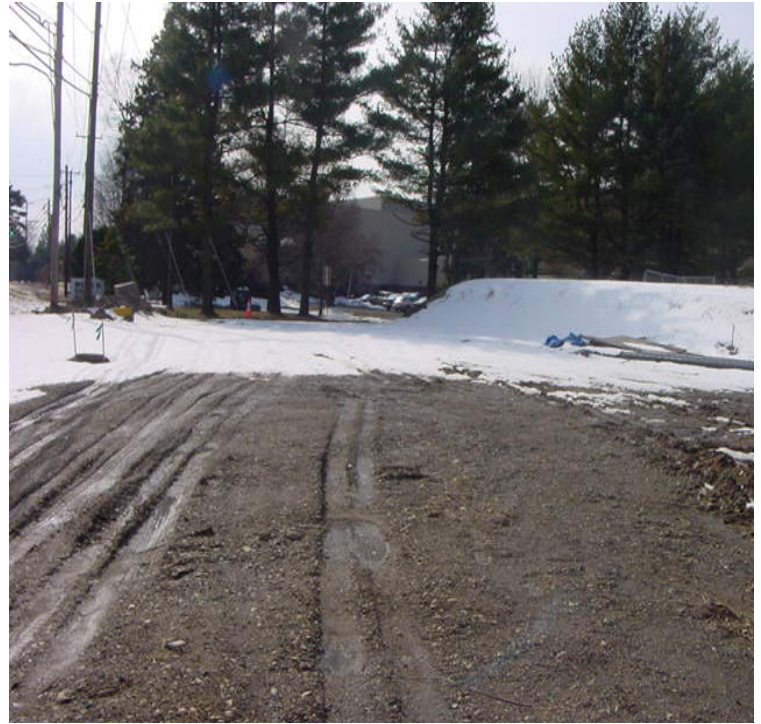
345kV (Georgetown Deli and High School) Photo shows the slope along the completed jack and bore site at Georgetown Deli which remains well stabilized. Photo on the right shows a view of the old jack and bore area near the high school. Final restoration is needed in the spring. 2/22/06

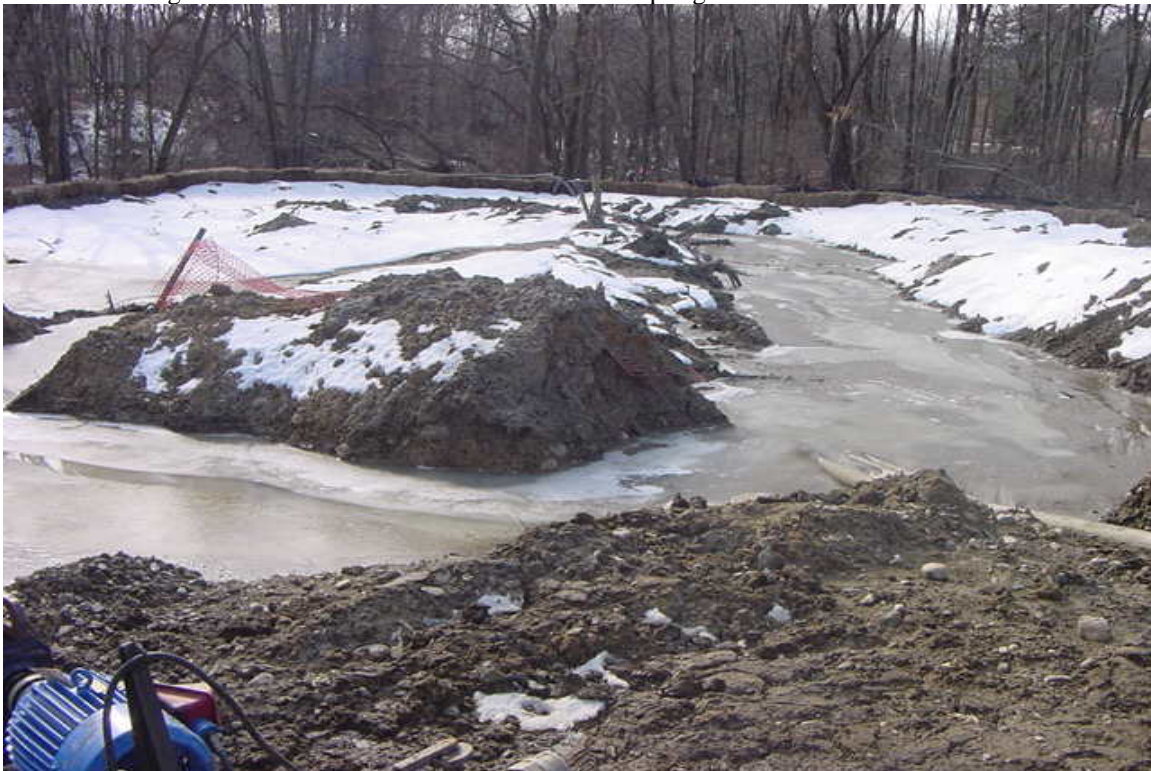
345kV (HDD): Photo shows an overview of the basin being used to hold the muds for the bore. The equipment here will be packing up soon. 2/22/06

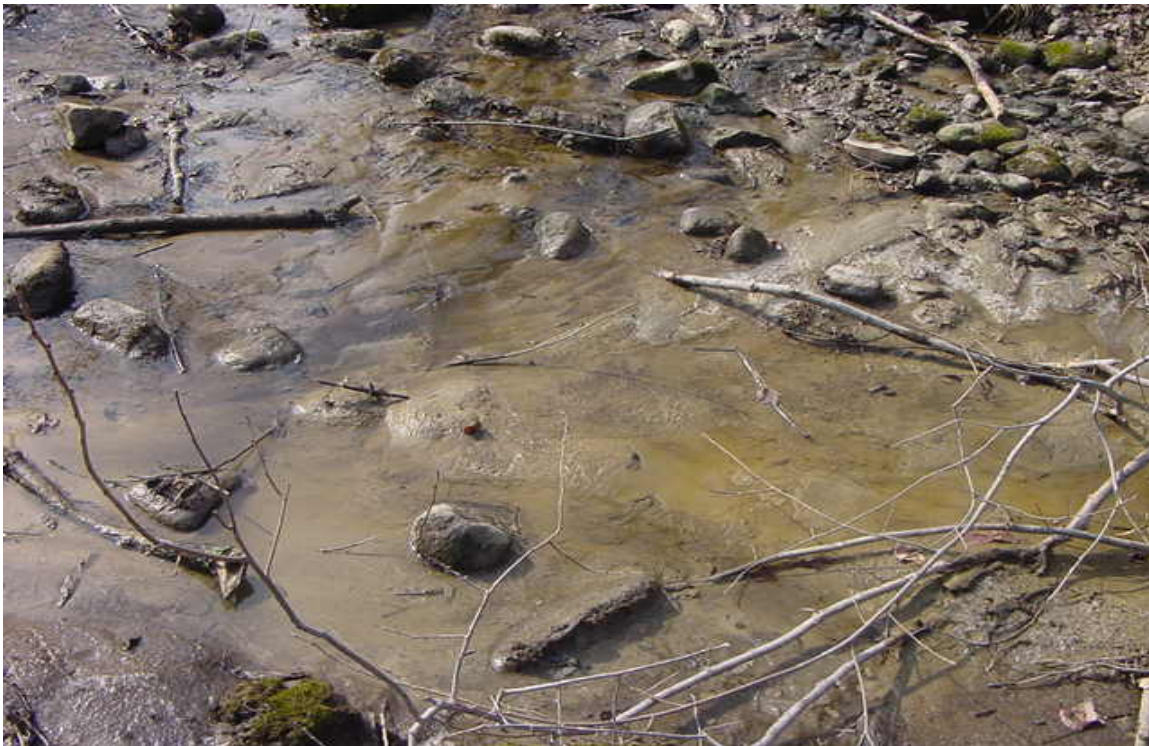
Photo shows a view of the wetlands beyond the basin and erosion controls. Sedimentation is occurring to the stream as a result of water from the site as well as migration of the soil that was disturbed several weeks ago. The sediment will need to be removed carefully by hand. 2/22/06

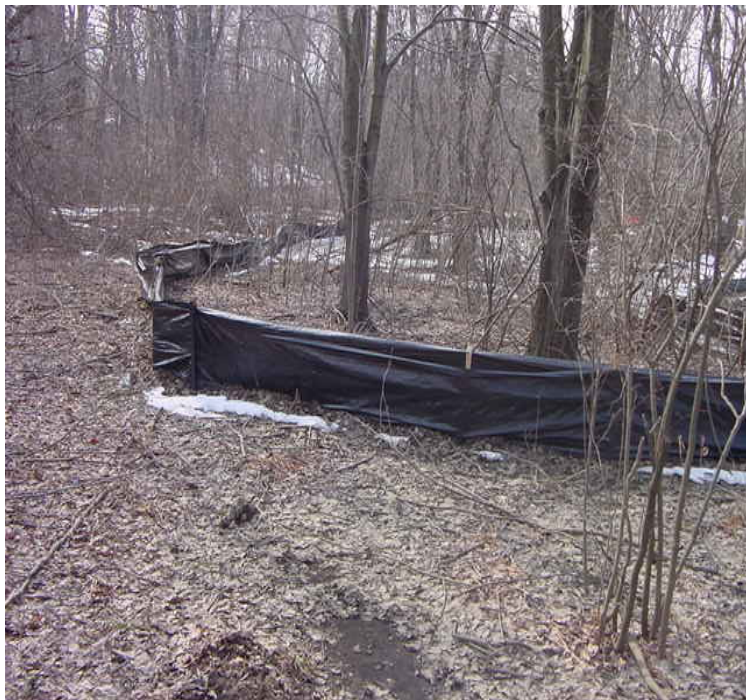
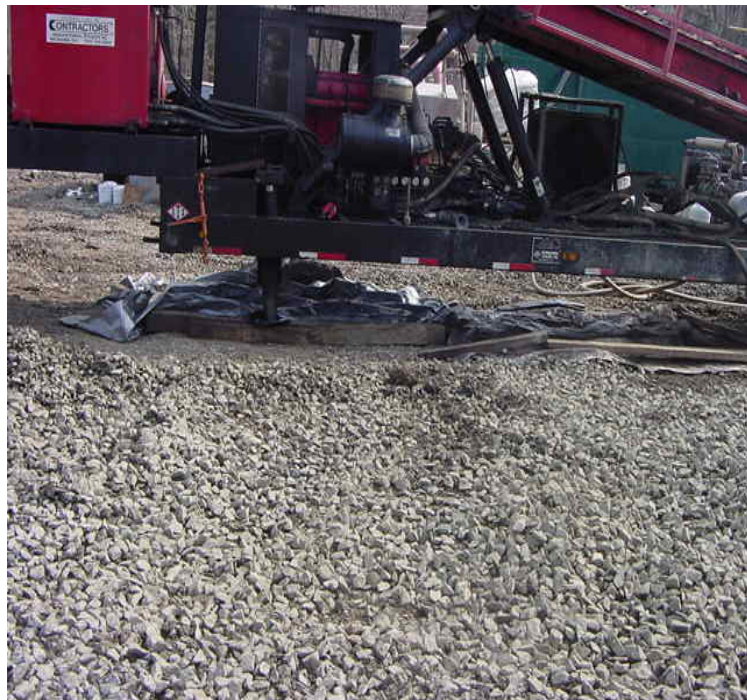
Photo on the left shows a view of the erosion controls along the eastern side of the site. Water from the street was washing through here last week. Photo on the right shows where additional tarp was installed under the leaking equipment as recommended. 2/22/06
